# Turkey Creek

STREAM HABITAT ASSESSMENT, STREAM CONDITIONS INDEX, LINEAR VEGETATION SURVEY, RAPID PERIPHYTON SURVEY AND WATER QUALITY

David Eilers, Liliana Sikes, Elizabeth Brauer, Seth Curtin | USF Water Institute | April 22, 2021

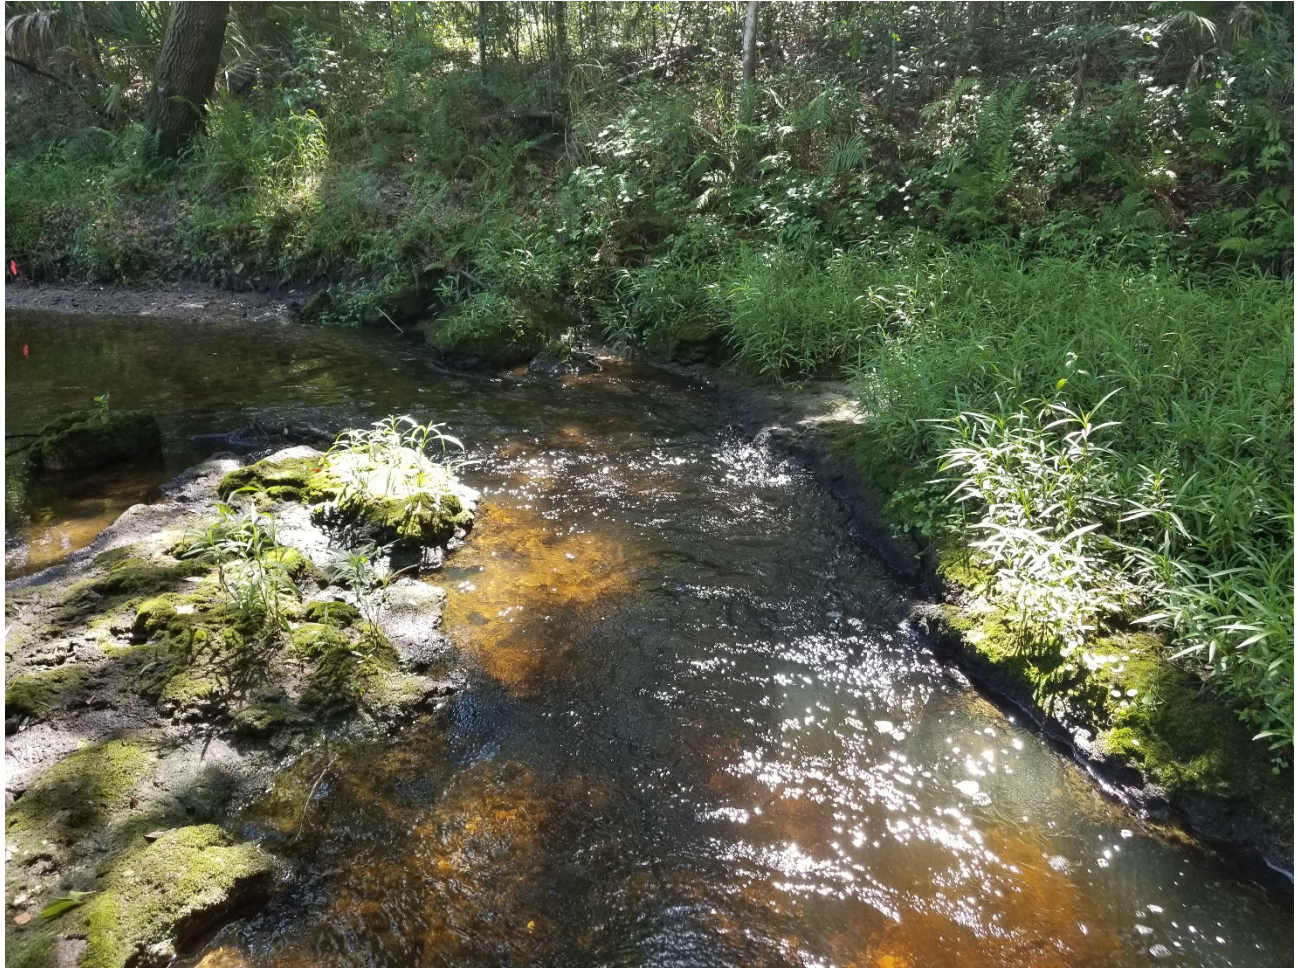
*Figure 2 Overview photograph of the Turkey Creek Sample Site showing the exposed limestone features*

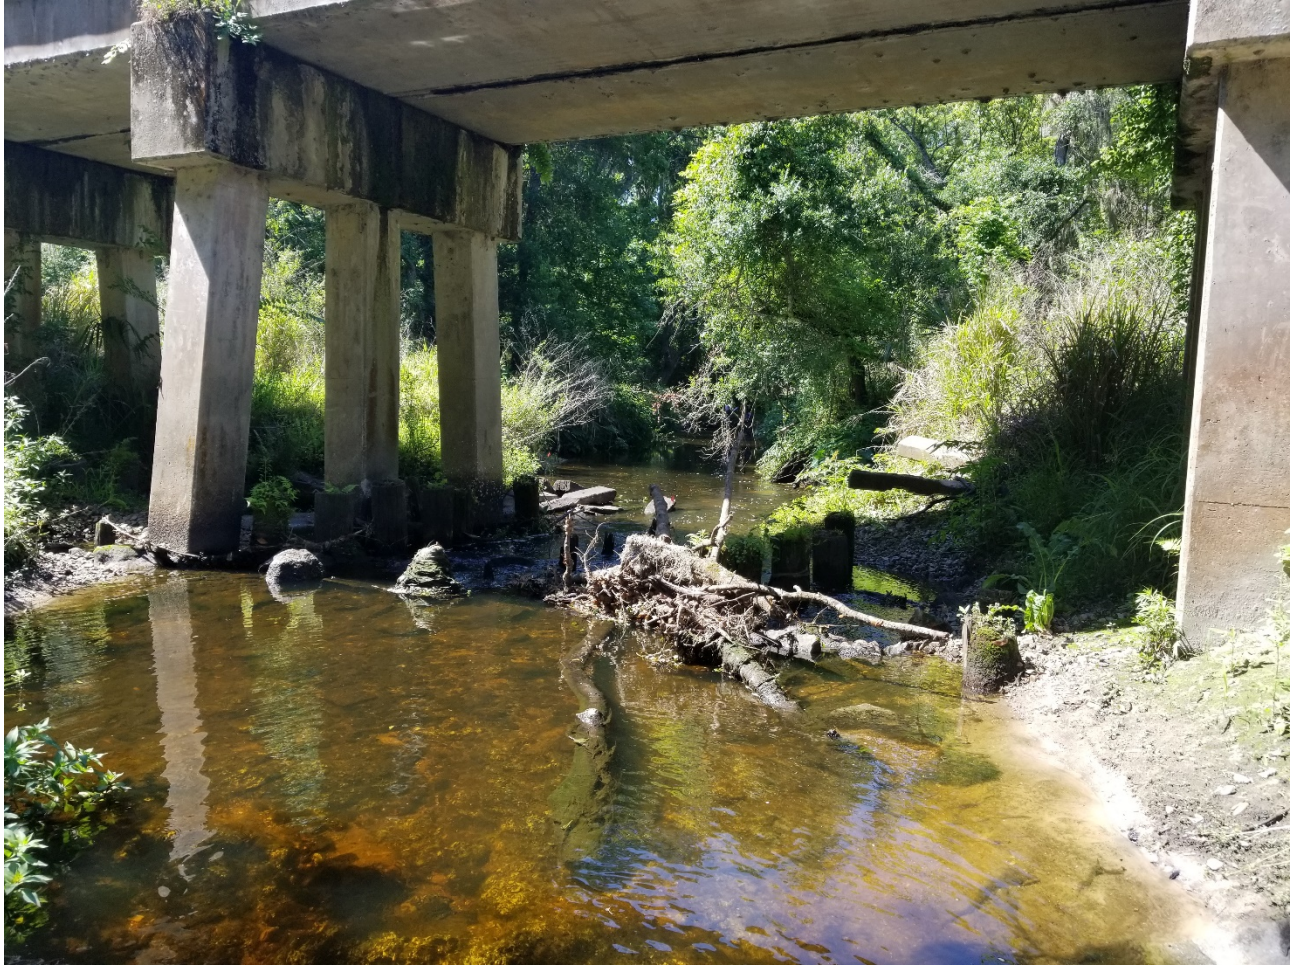
Periphyton was encountered during the 99 samples taken during the Rapid Periphyton Survey. Periphyton was observed in classes 4-6 (< 6mm to > 10cm) in 11 of the grab samples. These higher value samples were predominately in meters 60 through 90 where the canopy coverage was reduced near the rail road trestle crossing (24% canopy coverage average in regions 60-80 compared to 78.25% in the rest of the study area). The tree canopy in the assessment area averaged 63.5%.

*Figure 3 The area around the railroad trestle had a reduction of canopy coverage and an increase in periphyton abundance.*
