# CURIOSITY CREEK WATERSHED MANAGEMENT PLAN

FOR  
HILLSBOROUGH COUNTY  
Public Works Department/Engineering Division  
Stormwater Management Section

BY  
KISINGER CAMPO & ASSOCIATES CORP.  
2203 NORTH LOIS AVE., SUITE 1200  
TAMPA, FL 33607

JUNE, 2000

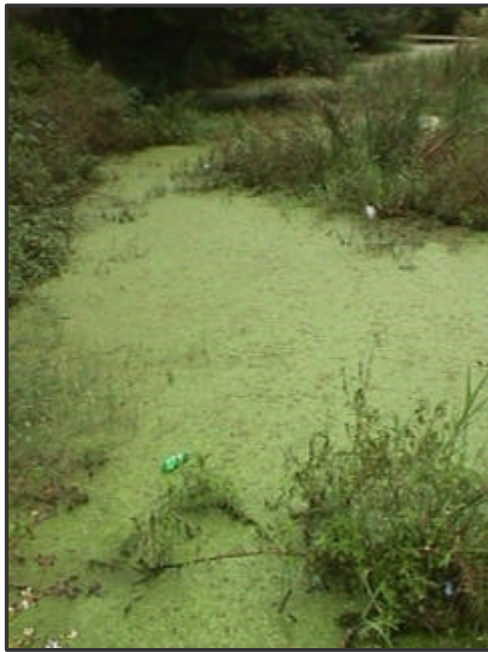
- Excess nutrients, primarily nitrogen and phosphorus, can cause an overabundance of nuisance aquatic weeds and blooms of algae in quiescent waters (Figure 7-1). An

overabundance of aquatic weeds reduces the capacity of a stream course to provide drainage during flooding events and can impede navigation. Algae blooms can depress oxygen concentrations and may cause taste and odor problems in drinking water. Some blue-green algae can produce harmful toxins.

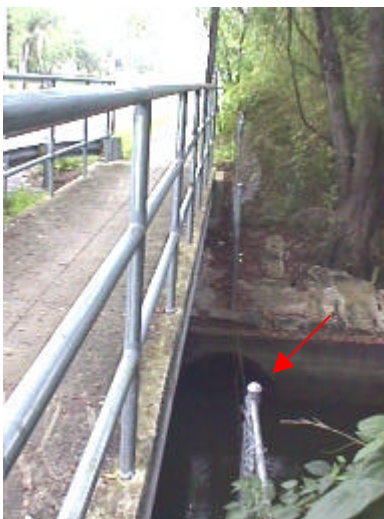
*Figure 7-2. Curiosity Creek at Country Club Drive looking east. Note red arrow pointing to 60” culvert at bottom of photo which discharges untreated stormwater runoff (from Florida Avenue) directly to the creek.*

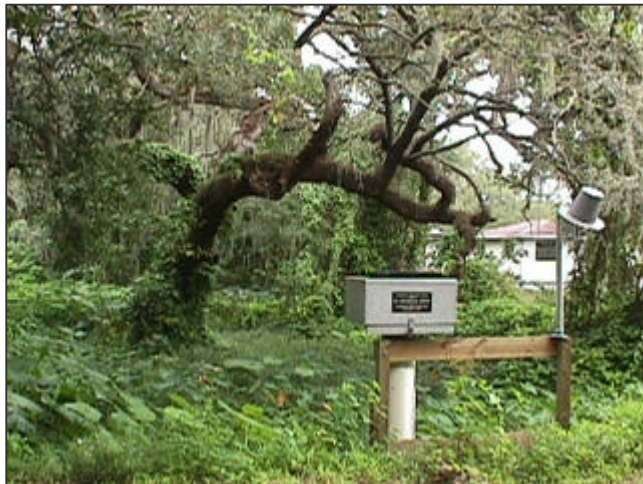
Figure 7-7. USGS gaging station #02305851 at 122<sup>nd</sup> Avenue on Curiosity Creek.

Currently, no long-term water quality data set exists for Curiosity Creek. Sporadic data are available from both the USGS and the HCEPC for common water quality parameters and bacteria (Figure 7-3). The longest water quality data set available was obtained from the USGS for station #2305780 (Curiosity Creek near Sulphur Springs). USGS staff collected samples at this station from October 1980 to September 1984 (Table 7-4).

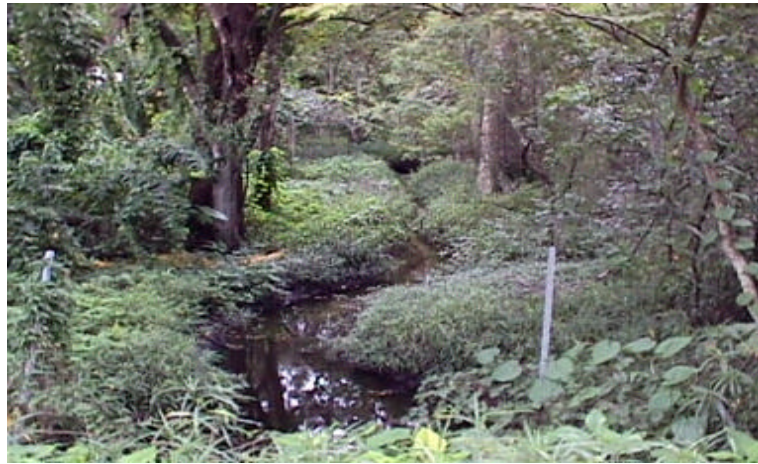
Figure 8-5. Wetland vegetation along the banks of Curiosity Creek at 122<sup>nd</sup> Avenue.

The following wetland habitat descriptions are based on the existing land use map of the Curiosity Creek watershed and the corresponding vegetation descriptions according to FLUCCS (1995). The Curiosity Creek watershed wetland and aquatic systems identified include mixed forest, freshwater marshes, wet prairies, emergent aquatic vegetation, intermittent ponds, and lakes. The Curiosity Creek channel was not identified by the existing land use map as a stream or waterway, but as other land uses due to dense vegetation cover and the intermittent nature of the creek (Figure 8-5).

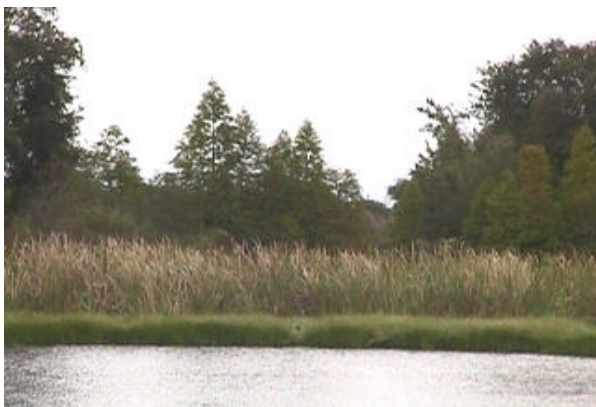
Figure 8-6. Existing mixed wetland forest at Lake Gass. Note small cypress trees in center of photo.

Approximately 6.6 acres of mixed wetland forest are present in the Curiosity Creek watershed, constituting 2.7% of the remaining natural systems and 0.3% of the total watershed area. The mixed wetland forest within the watershed is a cypress and oak association near the southern end of Lake Gass (Figure 8-6). The historical interpretation of soils indicates that this area would have been a cypress swamp.

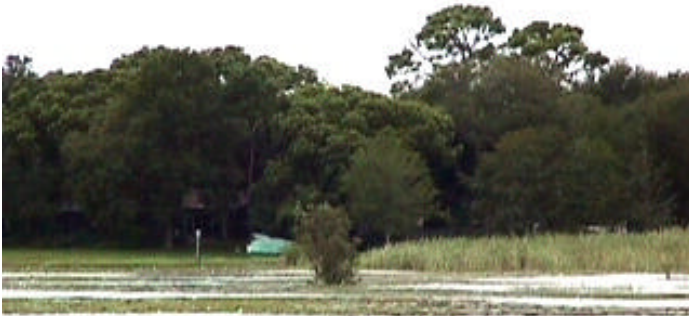
**Figure 8-7. Existing emergent aquatic vegetation along the shoreline of Lake Gass (note cattails on right side of photo, a solitary *Melaleuca* tree at the center, and lily pads at the lower half of the photo).**

Lakes are the most dominant natural features in the Curiosity Creek watershed (81.9 acres), constituting 32.9% of the remaining natural systems and 3.7% of the total watershed area. The 81.9 acres are not inclusive of the other lake-associated habitats (i.e. emergent aquatic vegetation) that were identified according to the existing land use maps. In general, most of the lakes in the watershed are open water bodies with fringes of emergent aquatic vegetation consisting primarily of water lilies and nuisance species including cattails (Figure 8-7). Exotic species including *Melaleuca* are common especially around Lake Gass and Lake Butler.

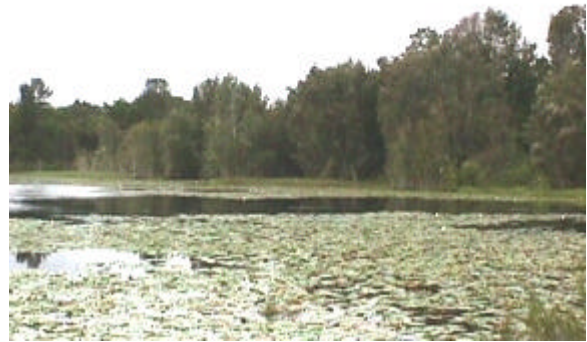
*Figure 8-10. Melaleuca at the perimeter of Lake Gass. Invasive exotics displace native species (cypress and hardwoods) and provide poor quality habitat for indigenous wildlife.*

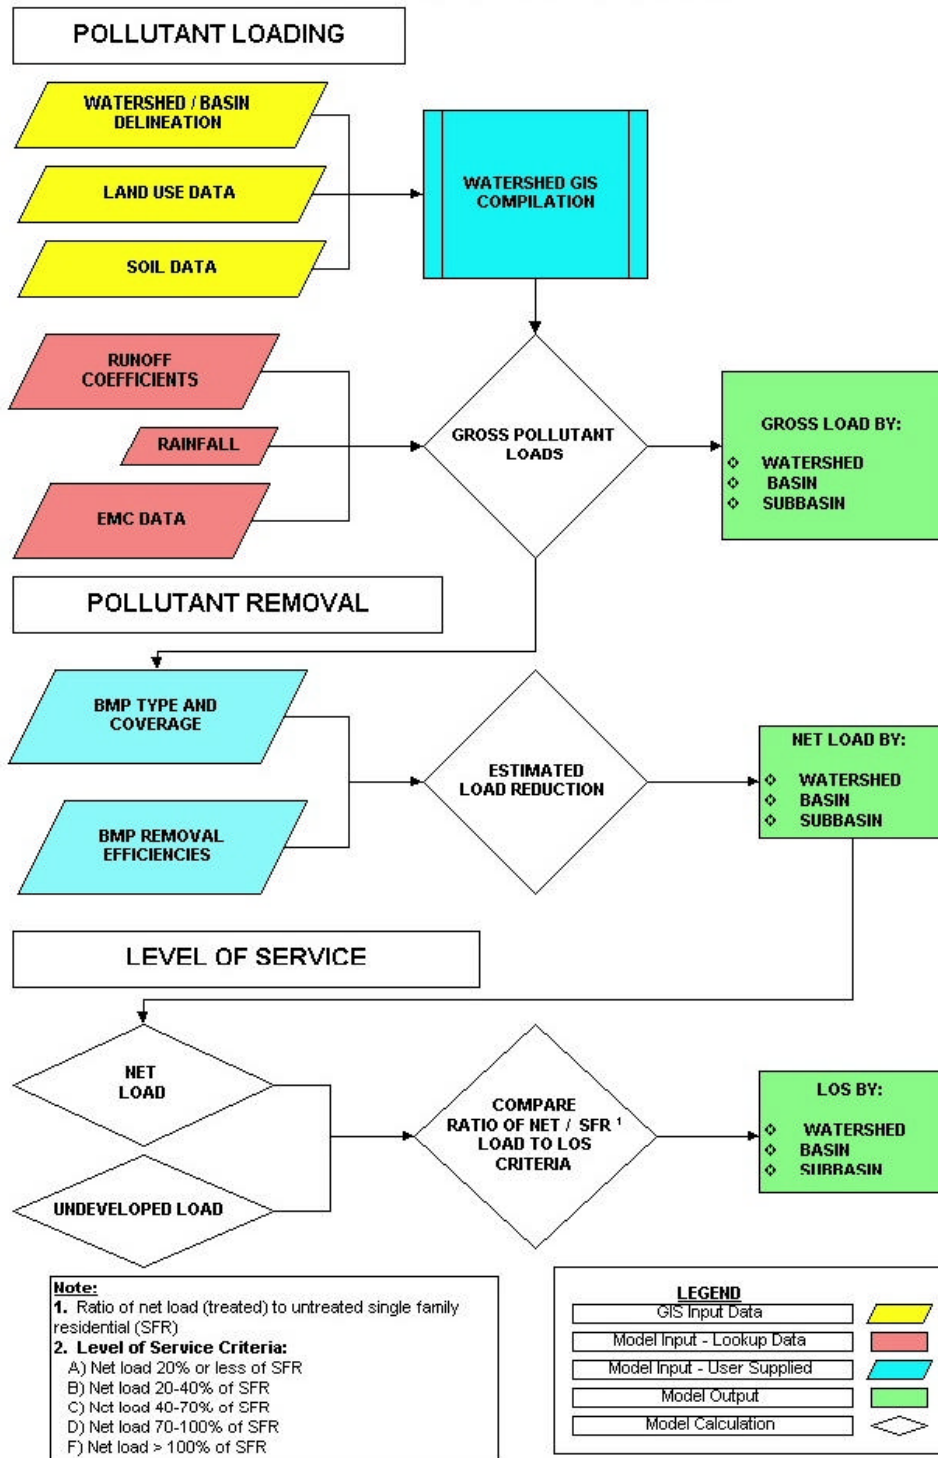
Figure 10-1. Hillsborough County Pollutant Loading and Removal Model. (Source: Parsons Engineering Science, Inc.)

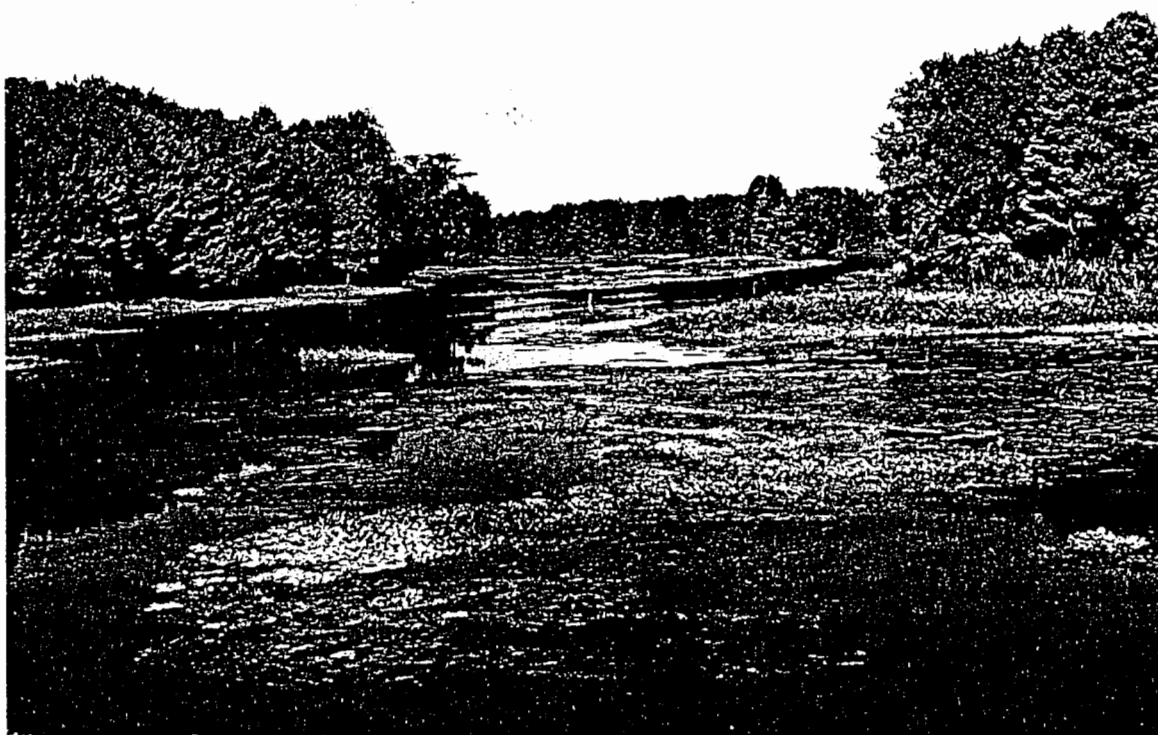
Figure 17. Horse Creek near Myakka Head. Relation of Manning's roughness coefficient to (A) discharge, (B) hydraulic radius, and (C) water-surface slope.

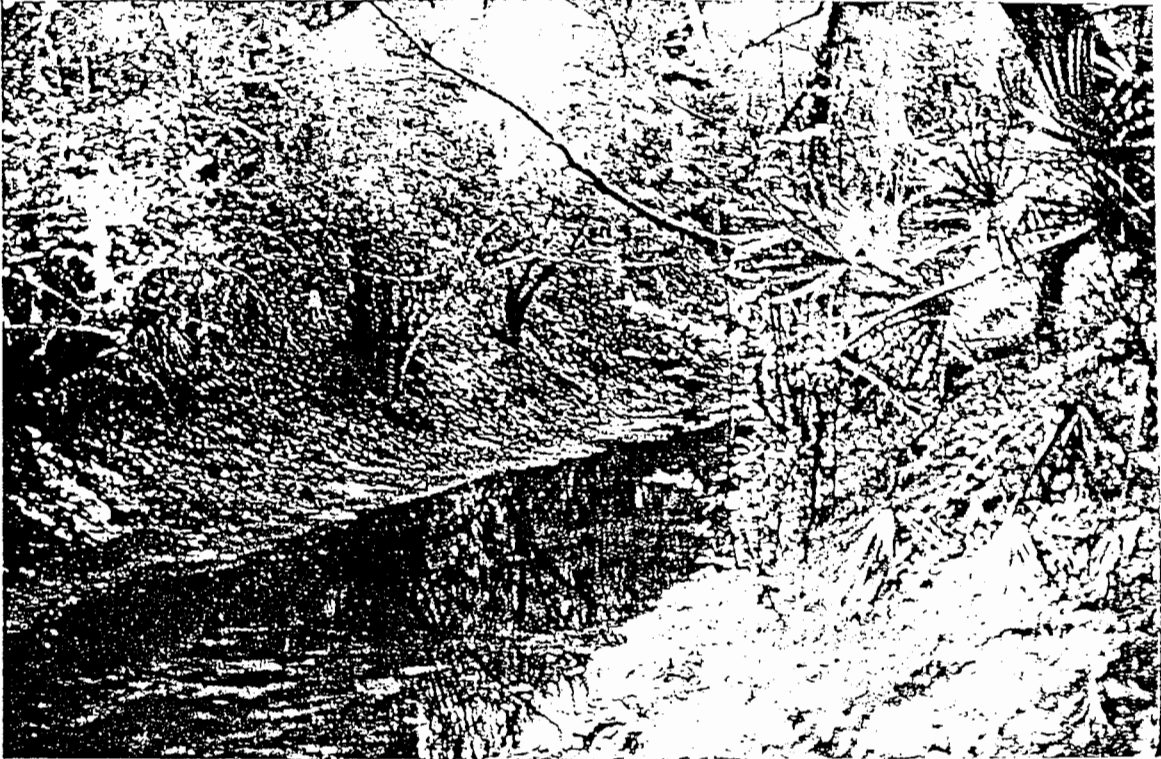
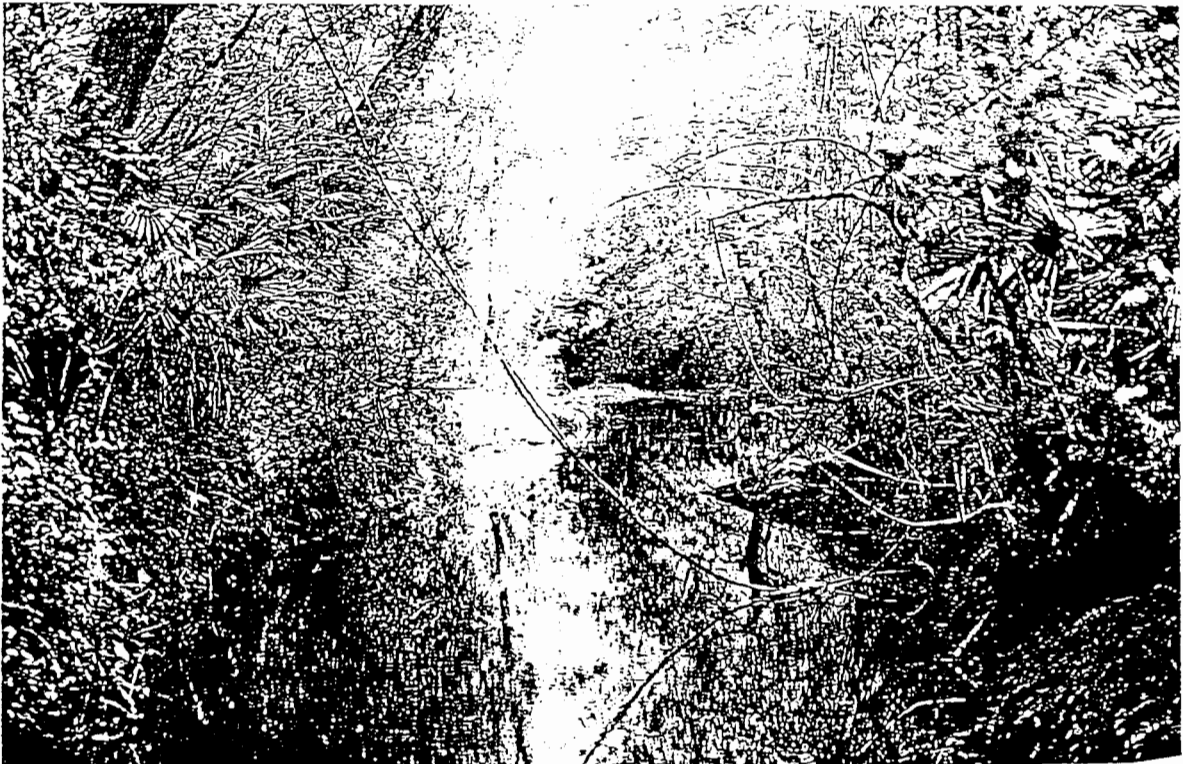
Figure 18. Horse Creek near Myakka Head. Photographs of channel looking (A) downstream from above cross section 1 and (B) looking downstream from above cross section 2.

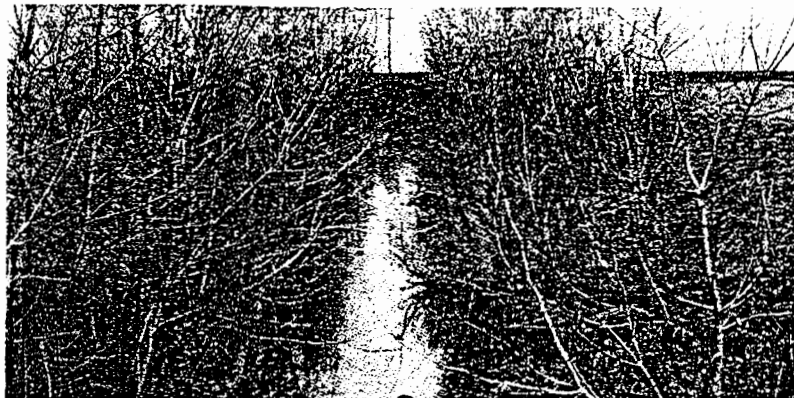
Kaskaskia Mutual Dredged Channel near Bondville, Illinois. Approximate bottom width 10 feet. Picture taken April 1925.

Date of observation	Average maximum depth	Average surface width	Discharge	Average cross section	Mean velocity	Mean hydraulic radius	Slope of water surface	Coefficient of roughness n	Description of channel
Feb. 7, 1925	2.1	16.5	21.9	24.6	0.89	1.36	0.000473	0.040	<i>Course</i> , straight; 330 feet long. <i>Cross section</i> , some variation in shape; for variation in size, see Figure 20, G. <i>Side slopes</i> , rather irregular. <i>Bottom</i> , rather irregular. <i>Soil</i> , lower part, black clay; upper part, dark-gray silty clay loam. <i>Condition</i> , badly obstructed by trees 1 to 6 inches in diameter on side slopes and edges of bottom; some weeds but practically no grass; no foliage. <i>Constructed</i> , 1902; cleared, about 1910. (Pl. 27, C and fig. 19, G.)
Mar. 16, 1925	3.0	18.9	45.5	39.6	1.15	1.89	.000424	.039	
Mar. 29, 1924	5.3	27.6	106.7	92.8	1.15	3.00	.000367	.051	
Feb. 25, 1926	5.7	29.6	100.7	105.7	.95	3.19	.000394	.067

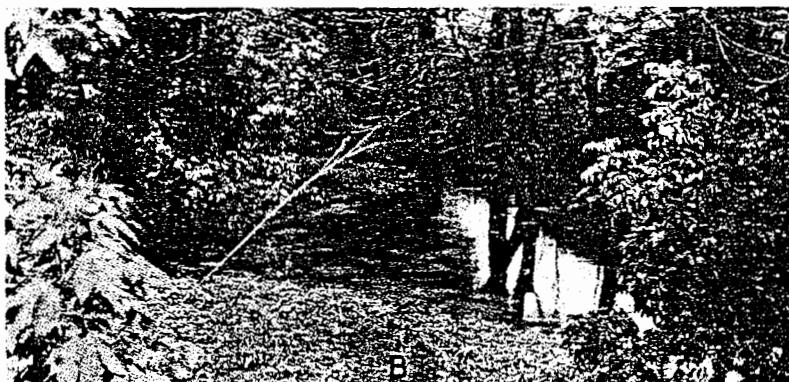
Kaskaskia Mutual Dredged Channel near Bondville, Illinois. Approximate bottom width 10 feet. Picture taken July 1927.

Date of observation	Average maximum depth	Average surface width	Discharge	Average cross section	Mean velocity	Mean hydraulic radius	Slope of water surface	Coefficient of roughness n	Description of channel
Sept. 23, 1926	4.3	23.8	48.0	68.8	0.70	2.58	0.000645	0.097	<i>Course</i> , nearly straight; 330 feet long. <i>Cross section</i> , some variation in shape; for variation in size, see Figure 20, F. <i>Side slopes</i> , irregular. <i>Bottom</i> , irregular. <i>Soil</i> , lower part, black clay; upper part, dark-gray silty clay loam. <i>Condition</i> , badly obstructed by trees 2 to 12 inches in diameter covering side slopes, except intervals aggregating half length of right bank occupied by large weeds and bushy willows; no foliage. <i>Constructed</i> , 1902; cleared, about 1910.
Sept. 9, 1926	7.5	34.3	111.5	157.8	.71	4.05	.000388	.110	
Oct. 2, 1926	8.0	36.6	132.3	176.4	.75	4.24	.000409	.111	
-----do-----	8.6	40.0	160.6	200.9	.80	4.43	.000421	.109

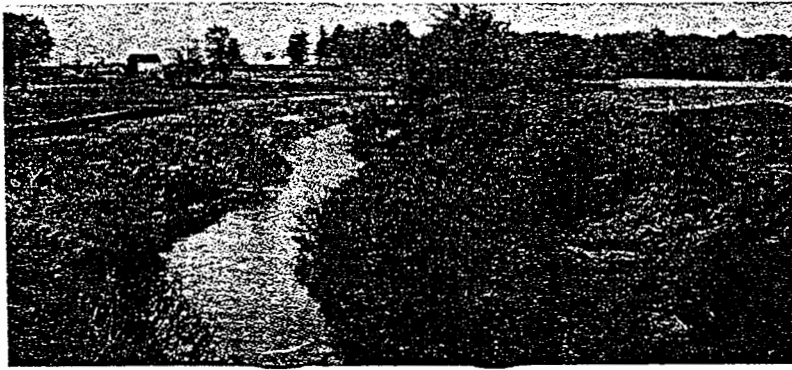
Kaskaskia River Dredged Channel near Sadorus, Illinois. Approximate bottom width 15 feet. Picture taken May 1926.

Date of observation	Average maximum depth	Average surface width	Discharge	Average cross section	Mean velocity	Mean hydraulic radius	Slope of water surface	Coefficient of roughness $n$	Description of channel
Jan. 18, 1926	5.2	37.6	249.1	130.6	1.91	3.15	0.000383	0.033	<i>Course, crooked; 600 feet long. Cross section, considerable variation in shape; for variation in size, see fig. 20, H. Side slopes, very irregular and uneven. Bottom, fairly even and regular. Soil, lower part, light bluish gray clay, which is hard, waxy, and slippery at the bottom; upper part, gray silt loam. Condition, very young growth and stubble on upper part of slopes, none on lower part; channel cleared in September, 1925. Constructed, 1907; vegetation cut about every 2 years. (Pl. 26, C and fig 19, H.)</i>
Feb. 26, 1926	6.2	43.0	321.0	169.5	1.89	3.58	.000485	.041	
Feb. 25, 1926	7.1	47.1	415.6	210.0	1.98	4.04	.000515	.044

Apr. 7, 1926	7.6	49.2	454.4	236.8	1.92	4.35	.000463	.046	
June 12, 1926	2.8	25.6	70.7	56.2	1.26	2.02	53.6	0.030	<i>Condition, left slope covered with weeds, right slope with willows, except near bottom.</i>
Sept. 17, 1926	3.2	26.8	69.8	66.8	1.04	2.28	44.4	.037	
Sept. 7, 1926	4.2	31.5	99.3	95.1	1.04	2.74	38.7	.044	
Sept. 13, 1926	4.9	36.2	138.4	120.5	1.15	3.04	39.1	.045	
Sept. 6, 1926	6.4	43.8	197.1	177.5	1.11	3.68	35.2	.053	
Sept. 5, 1926	7.4	48.3	260.2	225.4	1.15	4.22	28.9	.068	
Sept. 11, 1926	8.4	51.6	320.8	273.2	1.17	4.76	28.3	.072

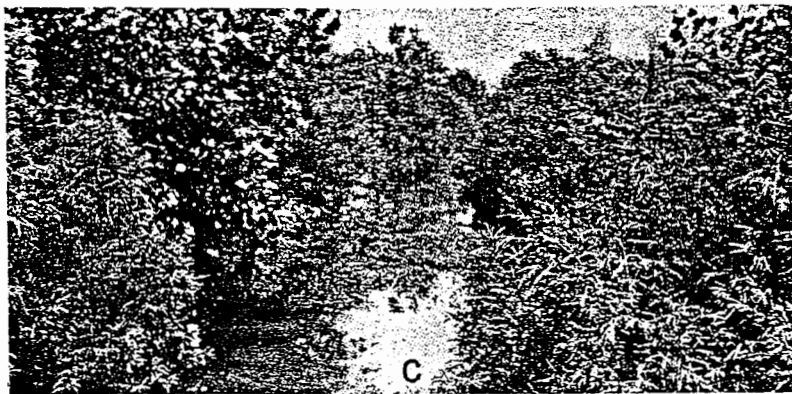
Camp Creek Dredged Channel near Seymore, Illinois. Approximate bottom width 15 feet. Picture taken July 1927.

Date of observation	Average maximum depth	Average surface width	Discharge	Average cross section	Mean velocity	Mean hydraulic radius	Slope of water surface	Coefficient of roughness $n$	Description of channel
Sept. 10, 1926	Feet 4.6	Feet 28.6	Second-foot 80.9	Sq. ft. 87.9	Ft. per sec. 0.69	Feet 2.84	0.000516	0.085	<i>Course, straight; 661 feet long. Cross section, very little variation in shape; for variation in size, see fig. 20, J. Side slopes, fairly regular. Bottom, uneven and irregular. Soil, lower part, yellowish gray clay; upper part, light gray silty clay loam. Condition, in 1924, newly cleaned leaving weeds and stubble on side slopes; in 1926, sides covered with trees and vines without foliage. Constructed, 1906; cleaned, winter of 1923-24.</i>
Oct. 2, 1926	7.3	36.0	164.9	175.7	.94	4.37	.000546	.104

*Condition, side slopes covered with heavy growth of poplar trees 2 to 3 inches in diameter, large willows, and climbing vines; thick growth of water weed on bottom. (Pl. 29, C.)*

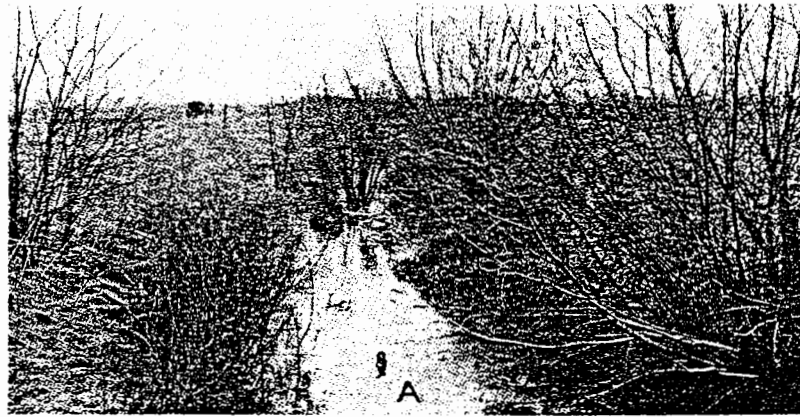
Two Mile Slough Dredged Channel near Sadorus, Illinois. Approximate bottom width 15 feet. Picture taken April 1925.

Date of observation	Average maximum depth	Average surface width	Discharge	Average cross section	Mean velocity	Mean hydraulic radius	Slope of water surface	Coefficient of roughness n	Description of channel
Mar. 13, 1925	2.7	18.3	25.6	32.6	0.79	1.64	0.000558	0.056	Course, straight; 360 feet long. Cross section, considerable variation in shape; for variation in size, see fig. 20, I. Side slopes, irregular. Bottom, very irregular. Soil, lower part, black slippery clay; upper part, gray silty clay loam. Condition, about 100 feet of course covered with dense growth of bushy willows, some in bottom; remainder of both slopes covered with weeds and a scattering growth of willows and poplars 1 to 6 inches in diameter; no foliage; some silting in bottom. Constructed, dredged 1905; cleared, 1921. (Pl. 28, A and fig. 19, I.)
Jan. 19, 1926	4.0	22.3	44.2	59.7	.74	2.43	.000550	.081	
Mar. 14, 1925	5.6	27.2	86.4	99.2	.87	3.25	.000464	.081

Feb. 25, 1926	5.8	27.9	101.4	107.0	.95	3.41	.000447	.076	
Mar. 19, 1925	5.8	28.1	105.1	106.6	.99	3.38	.000422	.070	
Jan. 18, 1926	6.0	28.4	92.7	111.4	.83	3.49	.000531	.096	
Apr. 7, 1926	7.5	32.7	159.5	158.7	1.01	4.24	.000500	.091

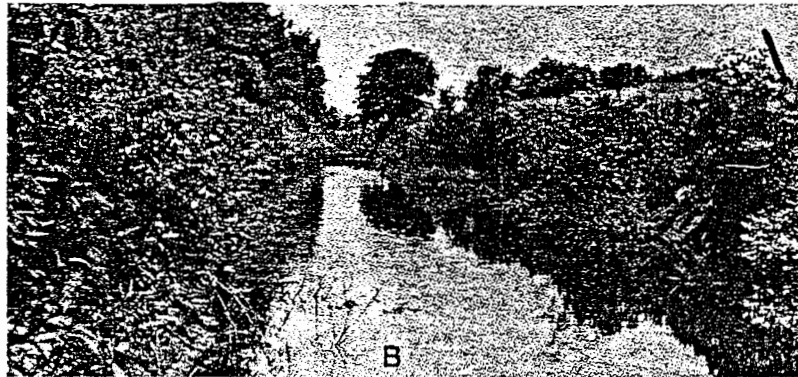
East Lake Fork Dredged Channel near Ivesdale, Illinois. Approximate bottom width 15 feet. Picture taken July 1927.

Date of observation	Average maximum depth	Average surface width	Discharge	Average cross section	Mean velocity	Mean hydraulic radius	Slope of water surface	Coefficient of roughness n	Description of channel
Sept. 7, 1926	5.2	28.4	64.0	101.6	0.63	3.24	0.000326	0.093	Course, straight; 800 feet long. Cross section, very little variation in shape; for variation in size, see Figure 20, E. Side slopes, rather irregular. Bottom, uneven and rather irregular. Soil, lower part, yellowish gray clay; upper part dark-gray silt loam. Condition, dead weeds and stubble on side slopes; channel had been cleared shortly before March, 1925. Constructed, 1885; dredged about 1904.
Sept. 5, 1926	6.1	30.5	77.2	126.8	.61	3.70	.000279	.100	
Sept. 13, 1926	7.2	33.5	124.6	162.1	.77	4.25	.000330	.097	
Sept. 11, 1926	8.8	41.3	170.8	222.2	.77	4.75	.000308	.103	
	19.5

Condition, left side rather steep, showing some tendency to cave; brush larger on side slopes; foliage on all vegetation. (Pl. 26, B.)

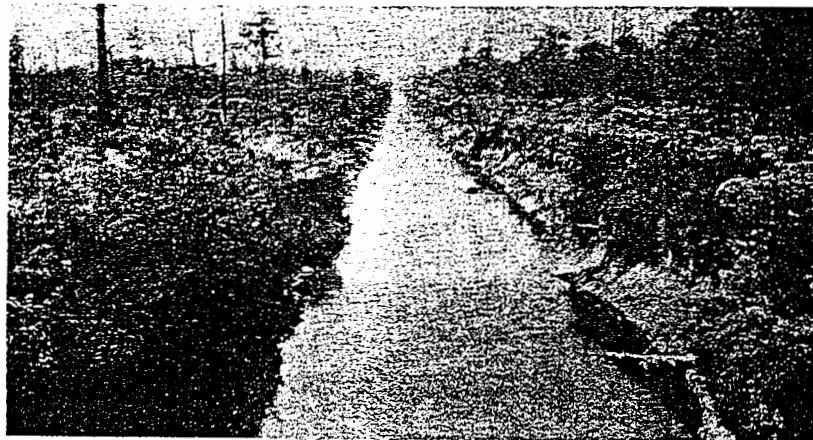
South Forked Deer River Dredged Channel near Henderson, Tennessee. Approximate bottom width 20 feet. Picture taken in 1916.

Date of observation	Average maximum depth	Average surface width	Discharge	Average cross section	Mean velocity	Mean hydraulic radius	Slope of water surface	Coefficient of roughness $n$	Description of channel
Mar. 30, 1916	3.2	26.1	115.2	73.3	1.57	2.46	0.000257	0.028	<i>Course, straight; 624 feet long. Cross section, very little variation in shape; for variation in size, see Fig. 6, C. Side slopes, slightly irregular. Bottom, fairly regular; uneven in places with small depressions. Soil, heavy clay near bottom; clay loam near top. Condition, practically no vegetation in channel. Constructed, November, 1914. (Pl. 7, B and fig. 5, C.)</i>
Mar. 1, 1916	3.8	27.1	169.4	89.0	1.90	2.81	.000393	.031	
May 16, 1916	3.9	27.4	193.2	91.5	2.11	2.87	.000305	.025	
May 22, 1916	5.8	30.4	358.0	147.0	2.43	3.96	.000361	.029	
May 3, 1916	6.4	31.5	434.6	168.3	2.58	4.34	.000345	.029	
	9.3
