Matheny Creek Stream Assessment

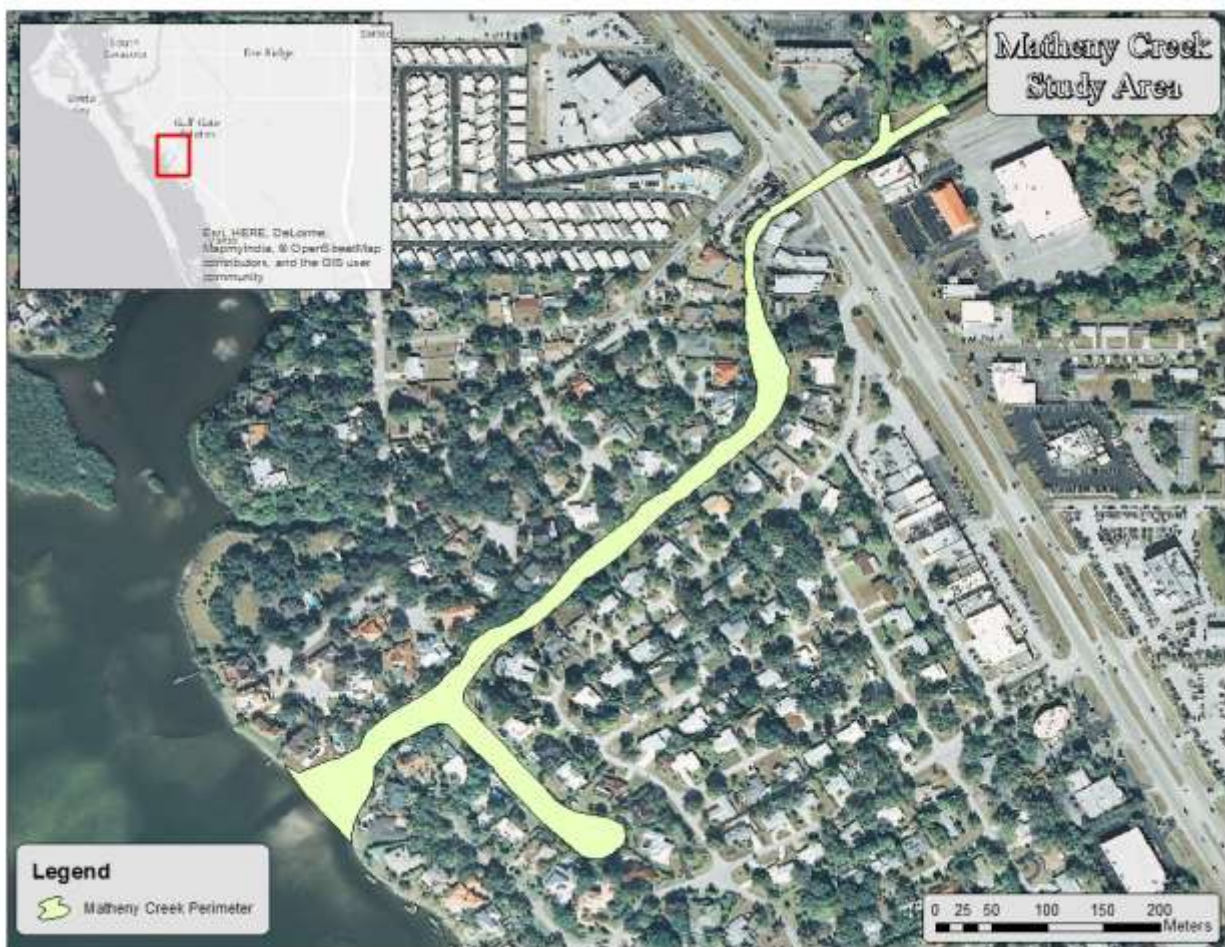
Matheny Creek was assessed on August 20, 2014. Matheny Creek has a highly urbanized watershed with residential (53%), commercial (10%) and industrial (8.15%) land uses. This creek is located in Sarasota County south of downtown Sarasota. The upstream portion of Matheny Creek is highly ditched and straightened with water level control weirs. Near the downstream portions, Matheny Creek has been fortified by seawalls. The watershed for Matheny Creek has an LDI value of 30.08 owing to the urbanization in the surrounding areas. Matheny Creek flows into Roberts Bay south of the Stickney Point Road Causeway.

Figure 16. Overview of the Matheny Creek Study Area

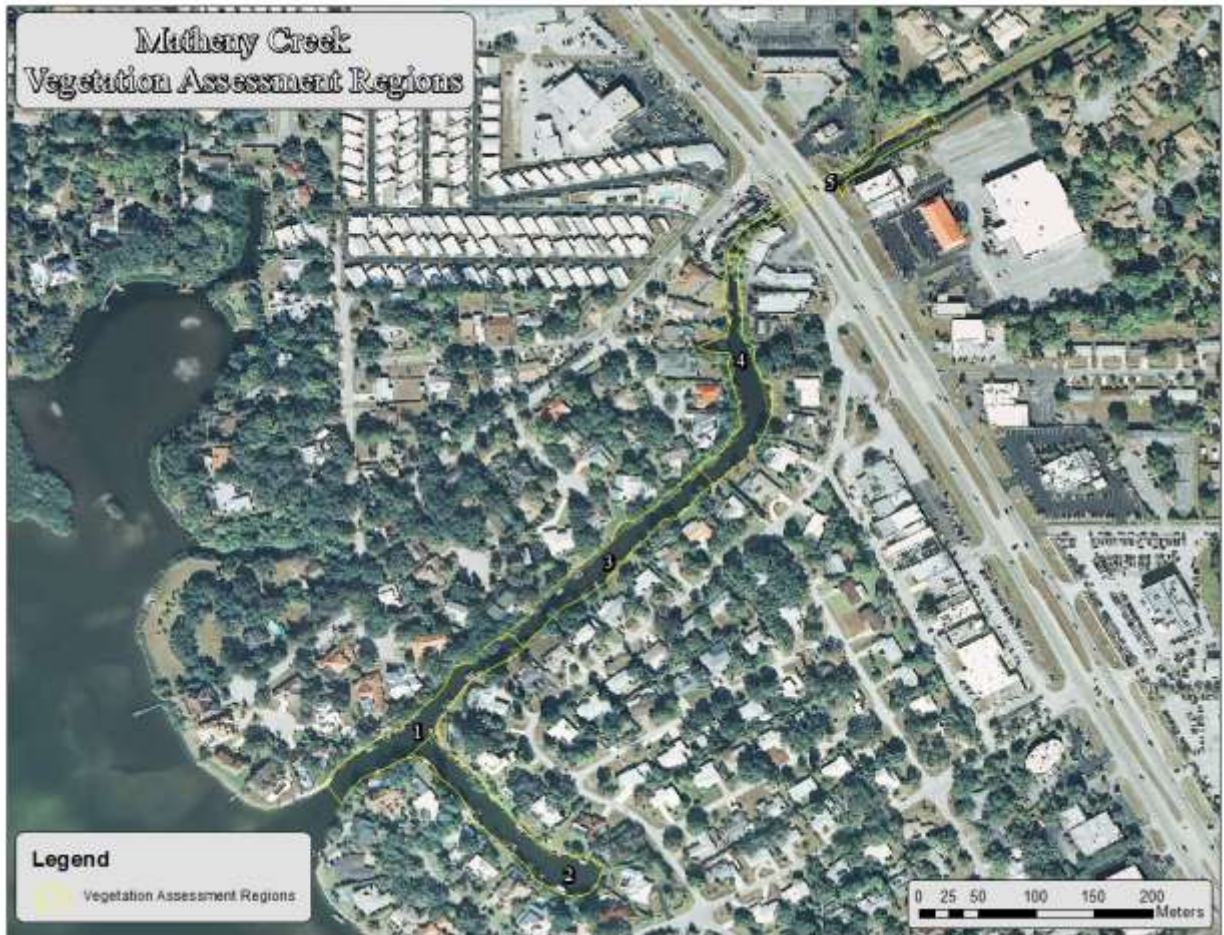
Figure 17. Overview of Matheny Creek Vegetation Assessment Regions

The Matheny Creek vegetation assessment encompassed 5 vegetation regions from the mouth in Roberts Bay to the water level control structures upstream from U.S. Highway 41 as shown in Figure 17. In these regions, 50 species of vegetation were identified. Regions 1 through 3 were dominated by mangroves (*Rhizophora mangle* and *Laguncularia racemosa*) with few other salt tolerant species

present. The first occurrence of Leather Fern (*Acrostichum danaeifolium*) was in Region 4. Above Region 4 the vegetation communities are populated by many species indicative of dominating freshwater influence.

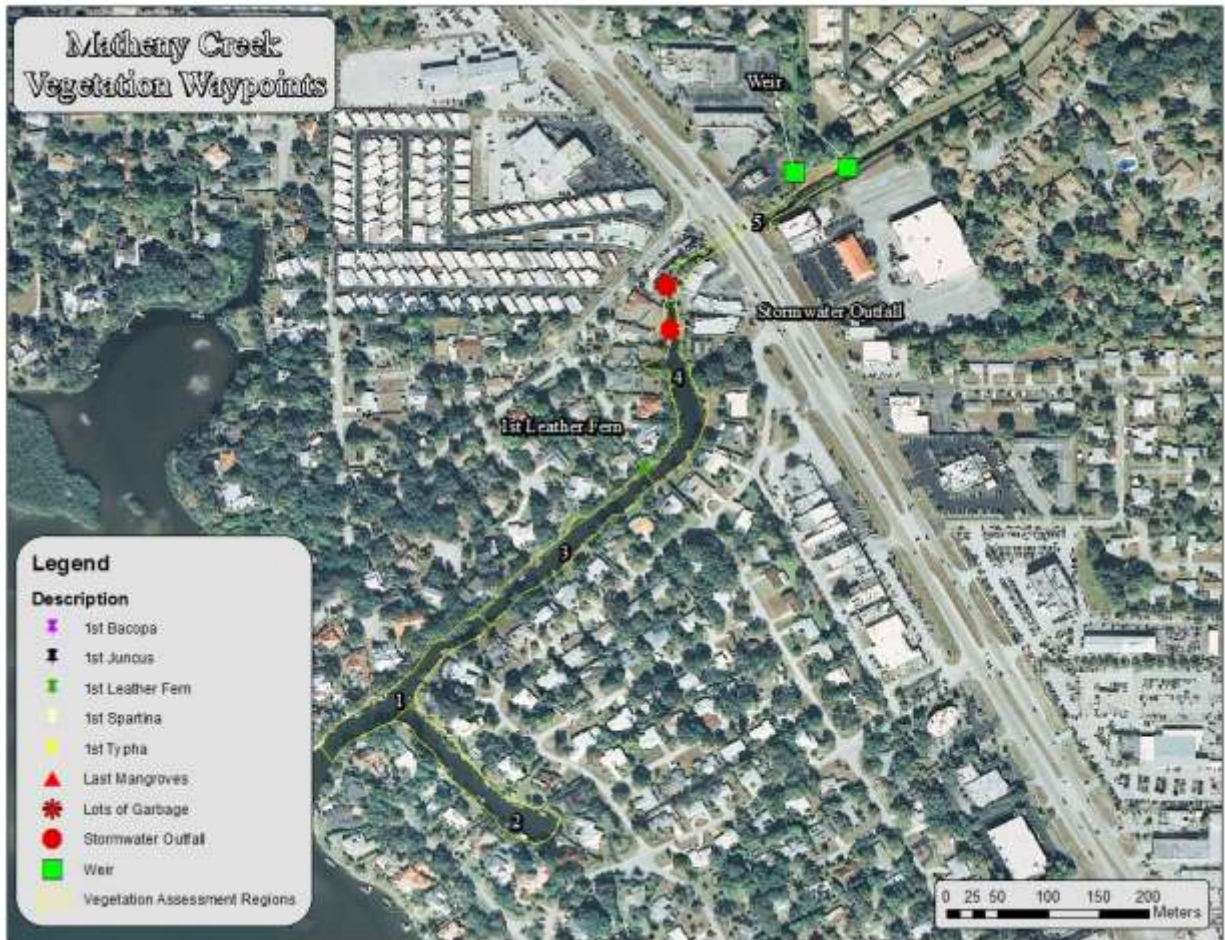
Figure 18. Matheny Creek Vegetation Waypoints

Figure 18 shows the vegetation transition zone of Matheny Creek indicating the most downstream Leather Fern, stormwater outfalls and weirs. Based on the vegetation assessment data for Matheny Creek, Regions 1 through 4 would comprise the highest salinity and tidal influence zone, Region 5 would comprise the “mixing” zone and regions above the weir at Region 5 would comprise the freshwater dominant zone. In the upper portion of Region 4 a limestone sill rapidly changes the exchange of fresh and salt water. The vegetation community changes rapidly above this point downstream from the weirs. The vegetation assessment species list is shown in Table 4.

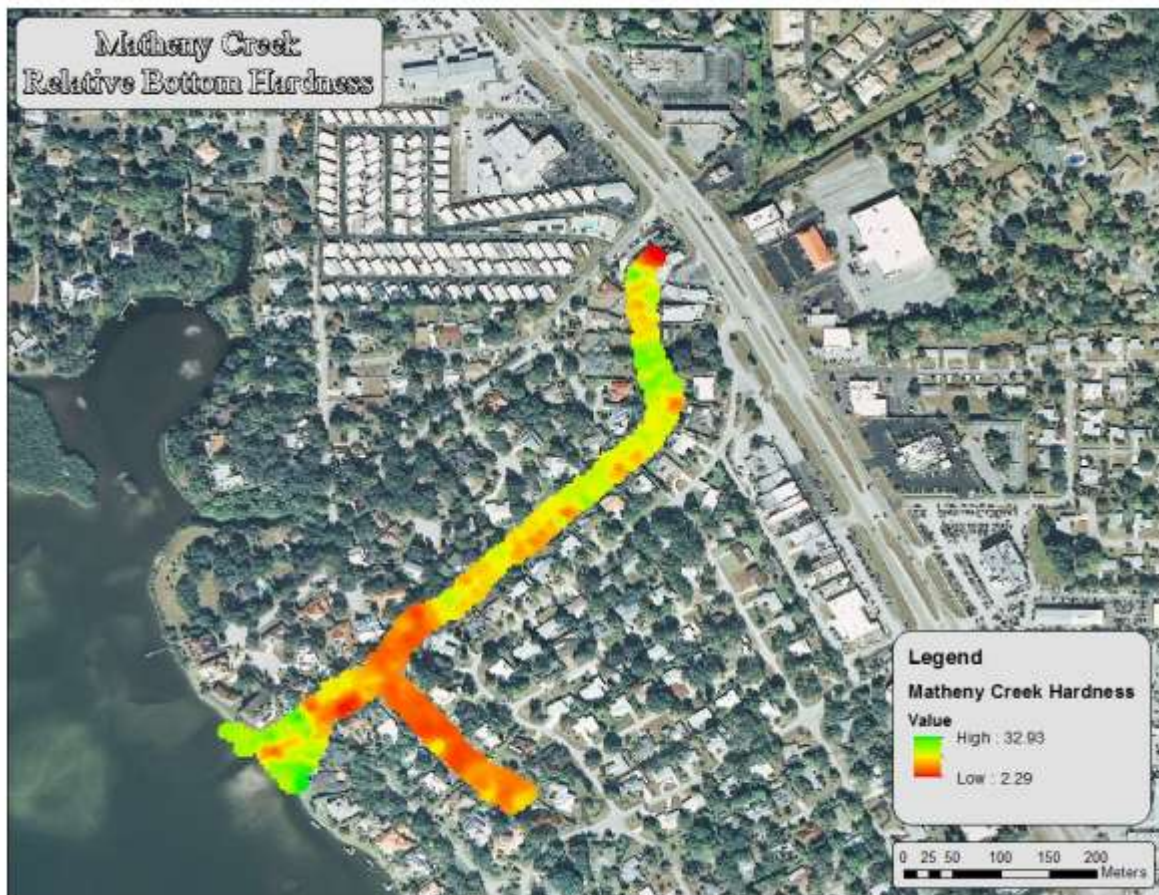
Figure 19. Matheny Creek Relative Bottom Hardness Map

Collected sonar data were processed through Dr. Depth software to analyze the strength of the return signal from the bottom to get an estimate of the relative bottom hardness for Matheny Creek. Figure 19 shows the bottom hardness raster for Matheny Creek. This map is meant to help identify locations of harder and softer bottoms for benthic invertebrate sampling, fish sampling and benthic chlorophyll sampling.

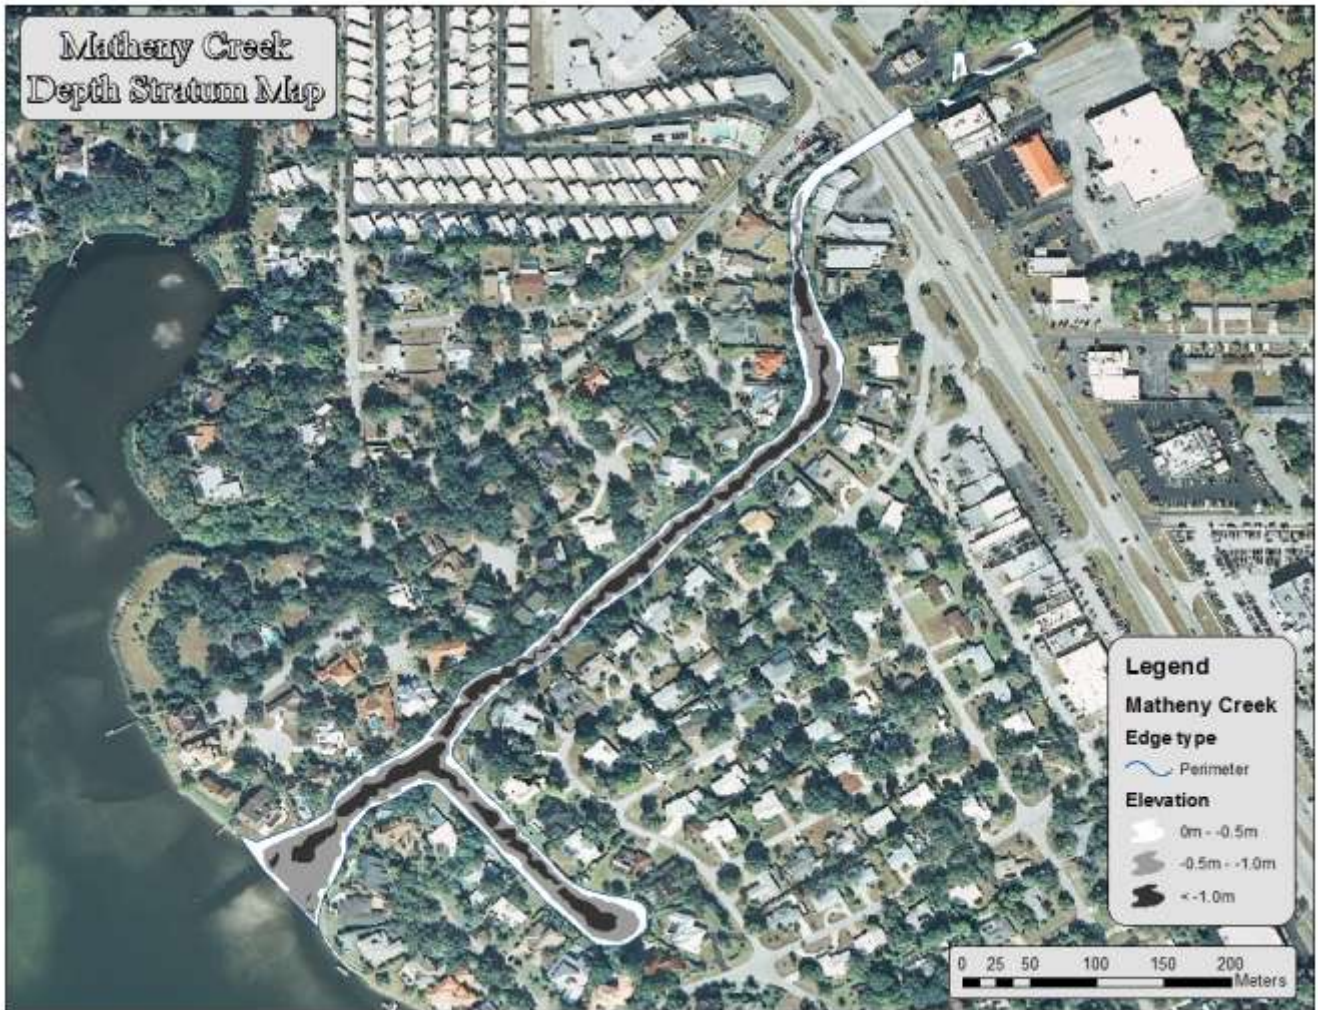
Figure 20. Matheny Creek Bathymetric Stratum Map

In the study area, Matheny Creek had a mean depth of 3.18 feet and a maximum depth of 6.07 feet. A total of 5.11 acres of creek was mapped during the assessment. At the time of assessment, Matheny Creek contained an estimated 3,636,872 gallons of water in the study area. The water level elevation was 4.95 feet at Sarasota ARMS MAT-1 station at the time of the assessment. Figure 20 details the bathymetric mapping for Matheny Creek showing the three depth strata.
