Mullet Creek Stream Assessment

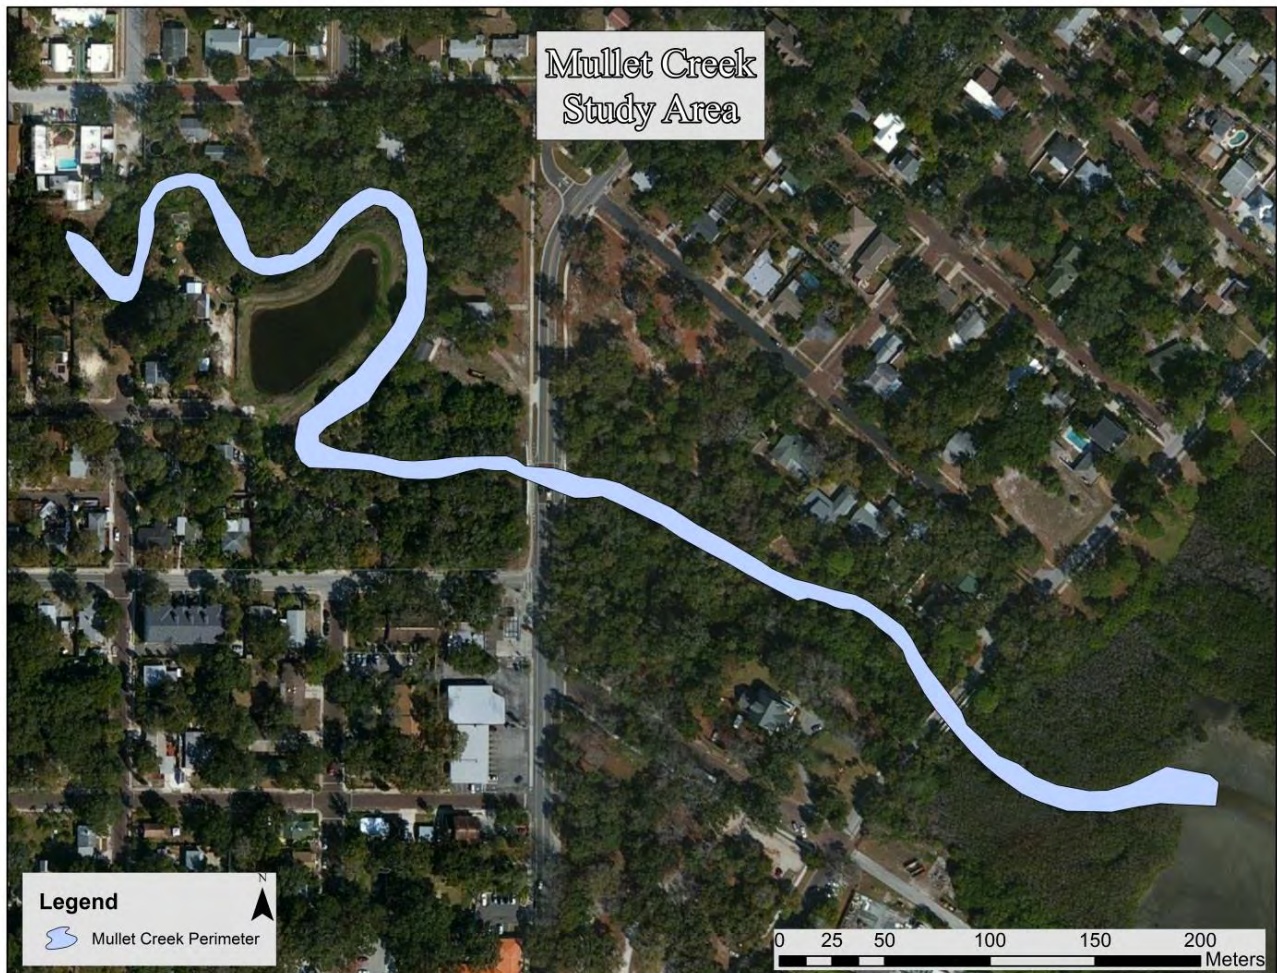
Mullet Creek flows into Old Tampa Bay. The watershed of Mullet Creek is urbanized containing both residential and commercial land uses resulting in a watershed Landscape Development Intensity (LDI) value of 7.0. Mullet Creek flows from through storm water ponds before finally discharging into a creek with natural vegetation buffers near its tidal reaches. Mullet Creek has a buffer LDI score of 6.5. There is a rated flow gauge located just above tidal influence which is also the site of a fixed water quality sampling station routinely sampled by Pinellas County.

Figure 1. Overview of the Mullet Creek Study Area

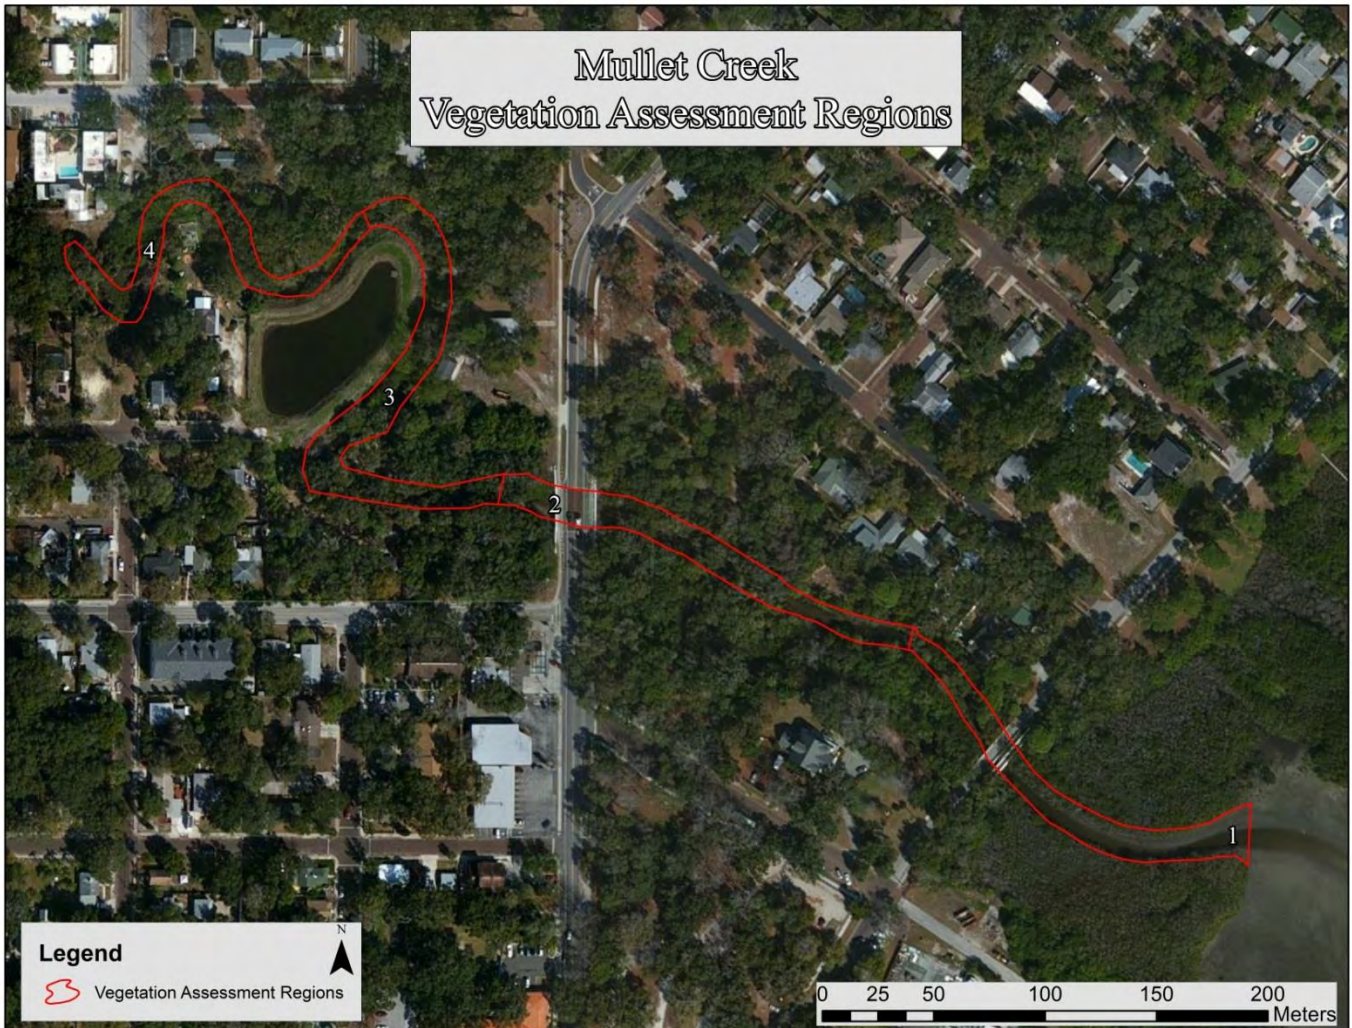
The Mullet Creek vegetation assessment encompassed four vegetation regions from the mouth in Old Tampa Bay as shown in Figure 2. In these regions, 70 species of vegetation were identified. Regions 1 and 2 were dominated by mangroves (*Rhizophora mangle*, *Laguncularia racemosa* and *Avicennia geminans*) with few other salt tolerant species present. The most upstream mangrove was *Rhizophora mangle* was in Region 4. The first occurrence of Leather Fern (*Acrostichum danaeifolium*) was in Region 1. Needle Rush (*Juncus roemerianus*) was first observed in Region 2.

Figure 2. Overview of Mullet Creek Vegetation Assessment Regions

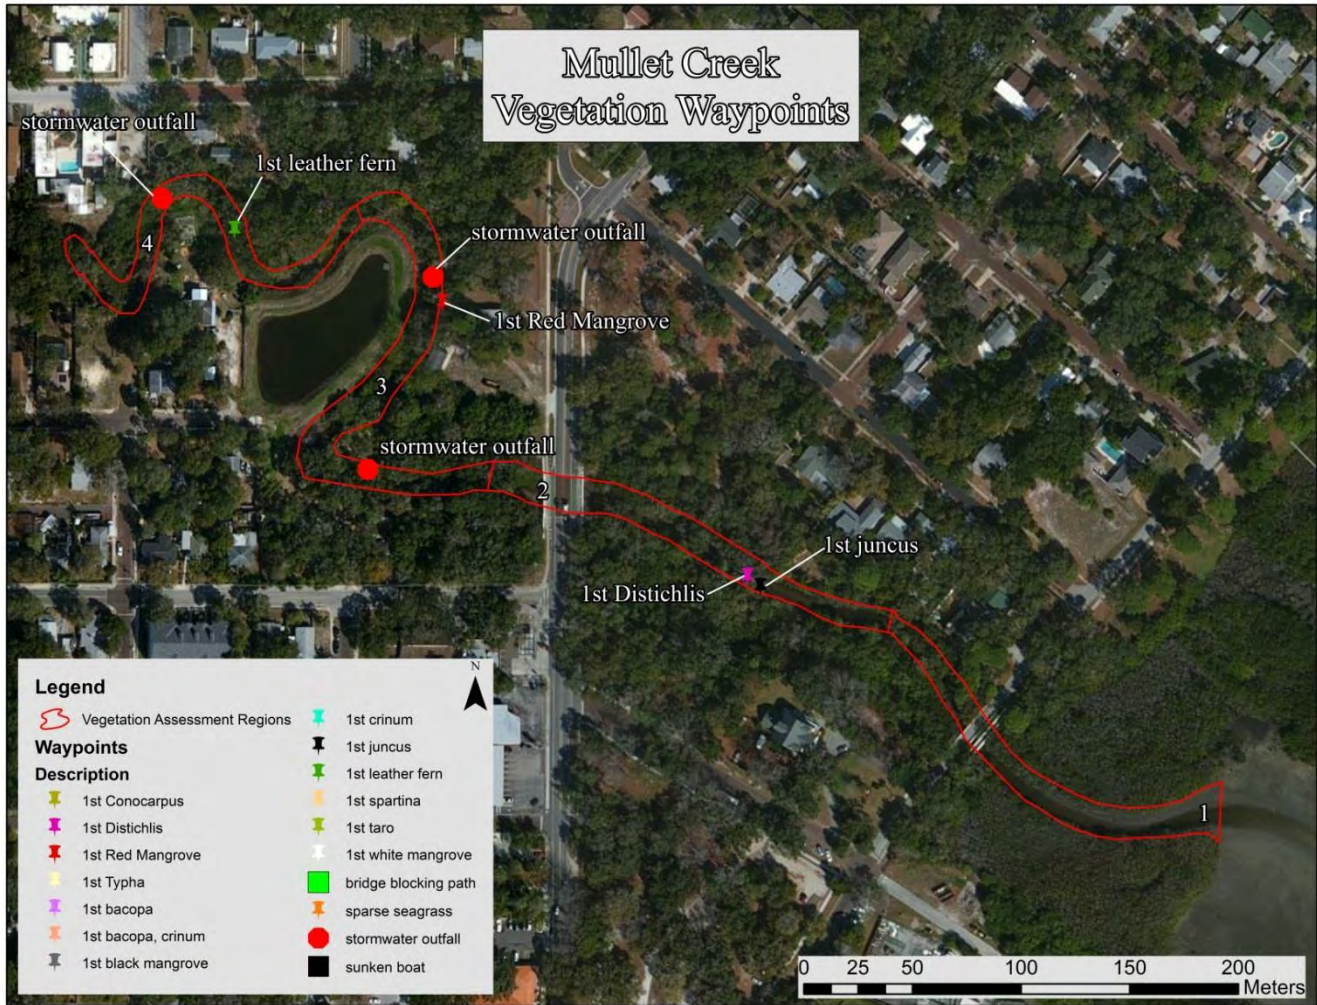
Figure 3 shows the vegetation transition zone of Mullet Creek indicating the most upstream Red Mangrove and Leather Fern as well as the most downstream *Distichlis* and *Juncus*. Based on the vegetation assessment data for Mullet Creek, regions 1 through 2 would comprise the highest salinity and tidal influence zone, Region 3 would comprise the “mixing” zone and Region 4 and above would comprise the freshwater dominant zone. The vegetation assessment species lists are shown in Table 1.

Figure 3. Mullet Creek Vegetation Waypoints

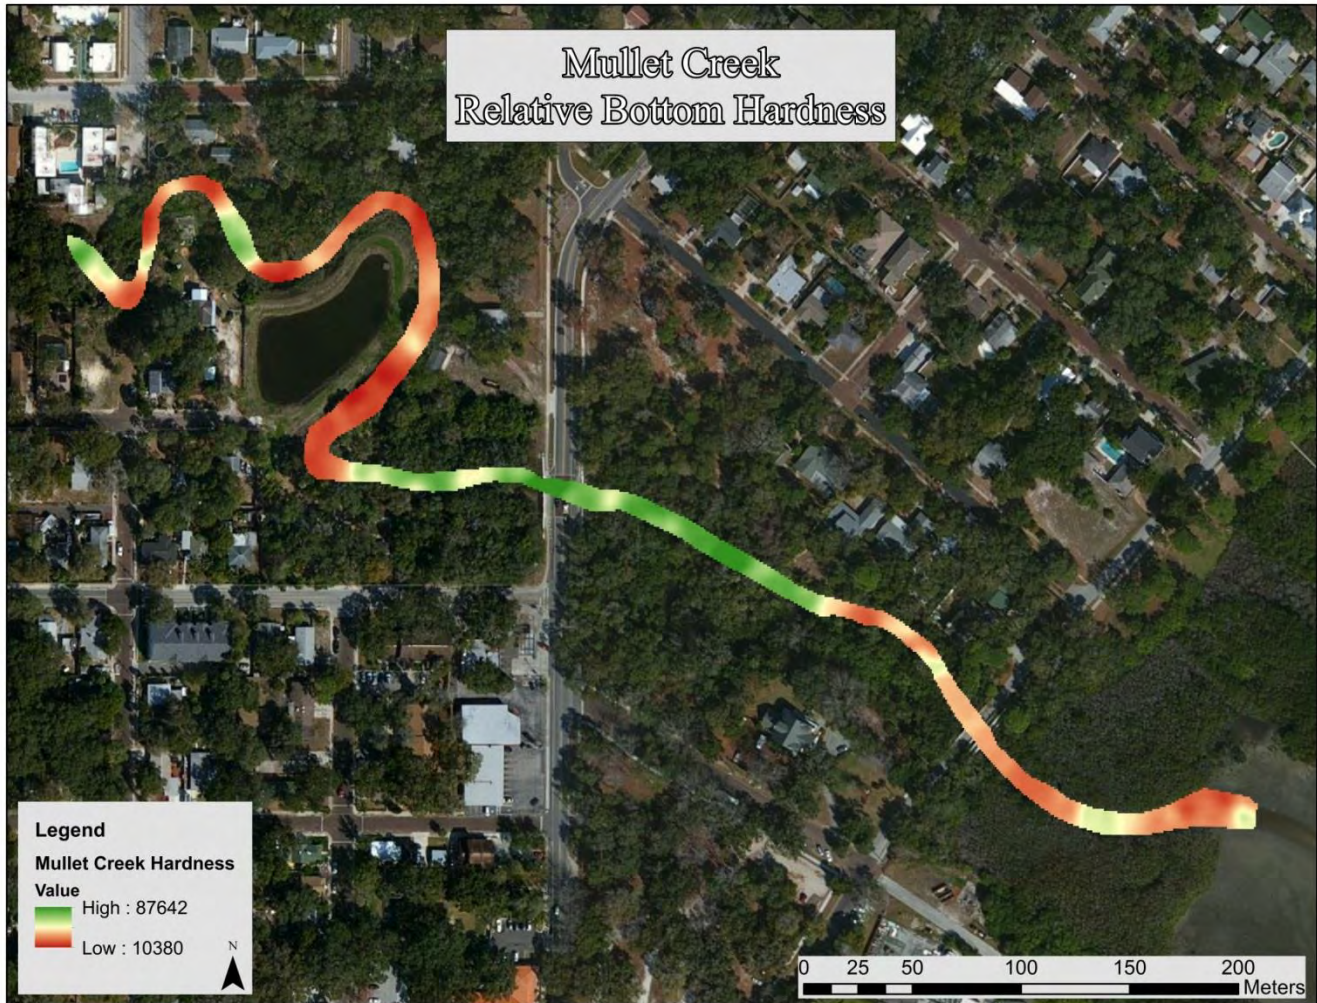
Collected sonar data was processed through Dr. Depth software to analyze the strength of the return signal from the bottom to get an estimate of the relative bottom hardness for Mullet Creek. Figure 4 shows the bottom hardness raster for Mullet Creek. In this raster, the higher the hardness value, the harder the bottom substrate. This map is meant to help identify locations of harder and softer bottoms for benthic invertebrate sampling, fish sampling and benthic chlorophyll sampling.

Figure 4. Mullet Creek Relative Bottom Hardness Map

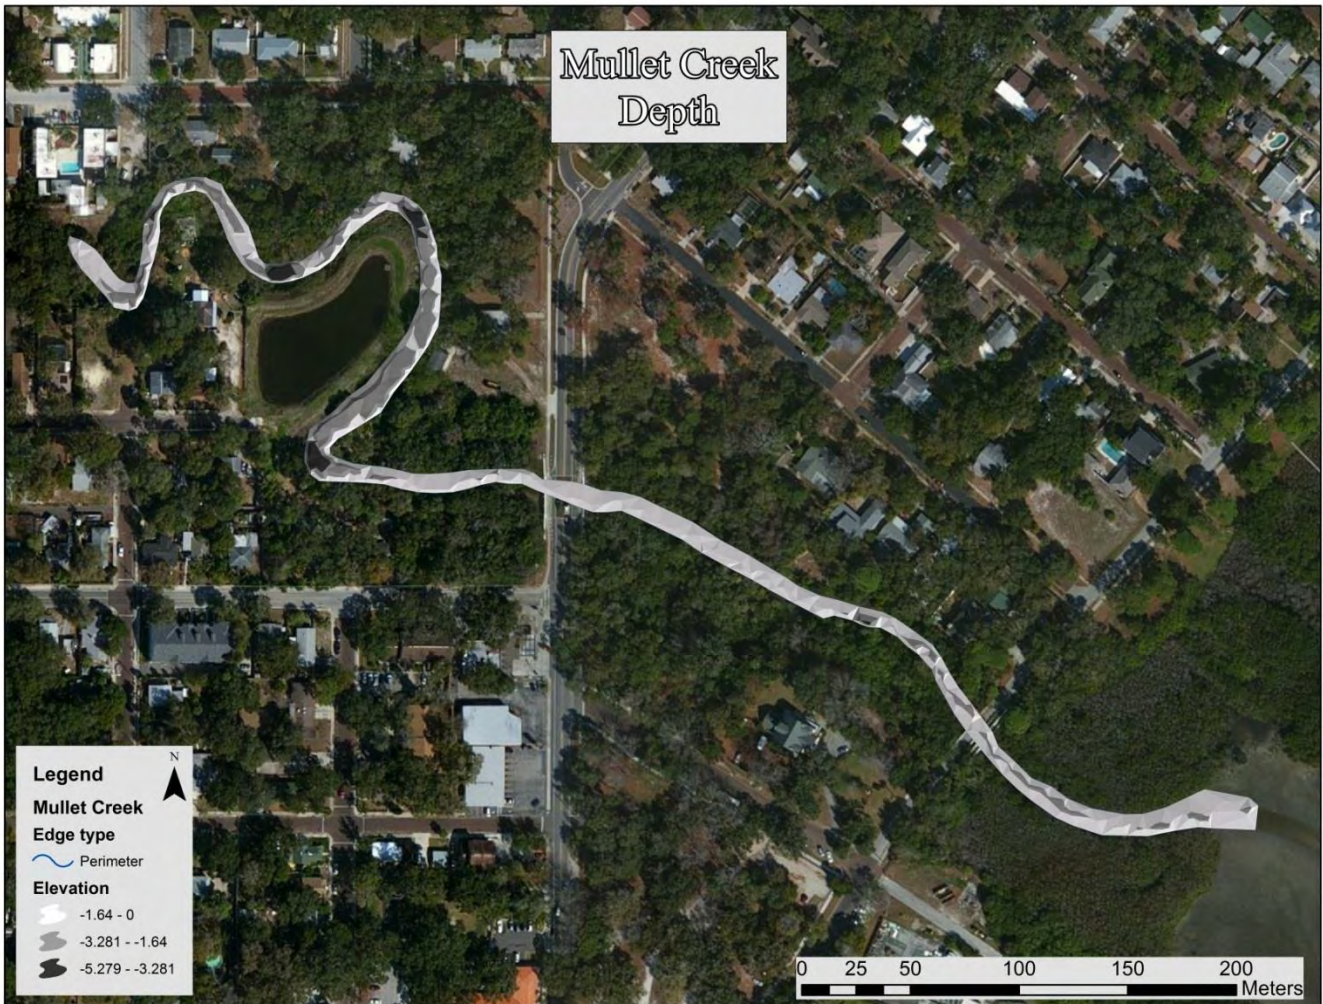
In the study area, Mullet Creek had a mean depth of 2.14 feet and a maximum depth of 5.44 feet. A total of 2 acres of creek was mapped during the assessment. At the time of assessment, Mullet Creek contained an estimated 795,253 gallons of water in the study area. Figure 5 details the bathymetric mapping for Mullet Creek showing the three depth stratum.

Figure 5. Mullet Creek Bathymetric Stratum Map
